## GREEN SCENE HOME INSPECTIONS

MARCUS BUTLER INSPECTOR TREC #20819

## PROPERTY INSPECTION REPORT

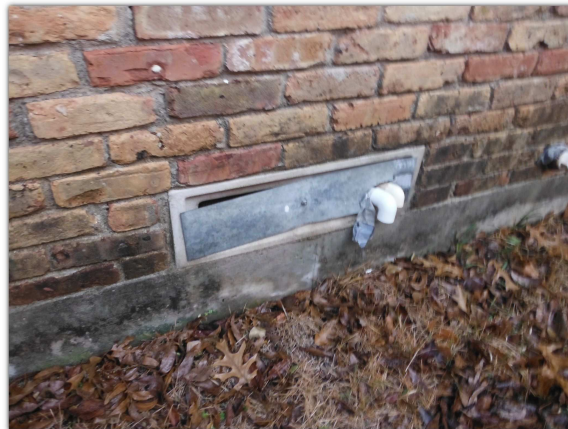
- **Note:** Tree(s) in close proximity of the foundation was observed. Client should consider the installation of a root barrier to reduce the possibility of damage to the foundation from tree roots and moisture removal.
- **Note:** The heavy foliage growing on, over or around the exterior foundation of the structure should be trimmed back at least 18-inches. The heavy foliage will limit the Inspector's visual observation of the exterior surfaces and is conducive for wood-destroying insect activity and/or wood rot.
- All wood debris and/or trash should be removed from the crawl space. This condition is conducive for wood-destroying insect activity.
- Obstructed crawl space wall vents should be cleared and/or opened to help improve ventilation.

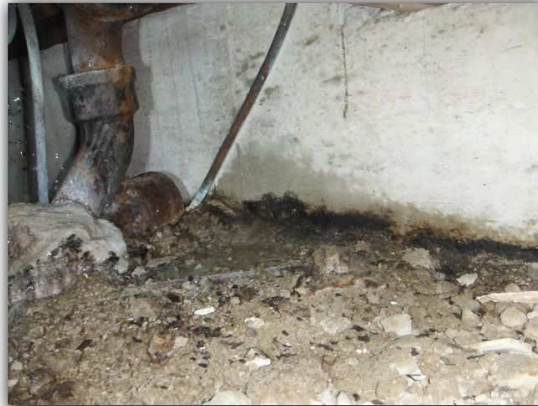
- The sub-floor material has some deterioration and/or damage under the furnace. This is a conducive condition for wood destroying insects and should be further evaluated and corrected as necessary.
- All wood debris and/or trash should be removed from the crawl space. This condition is conducive for wood-destroying insect activity.

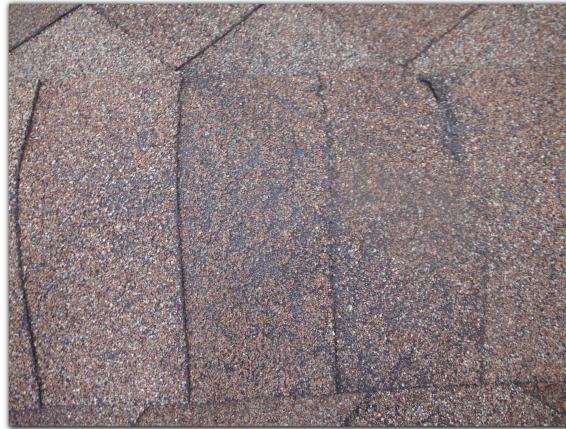
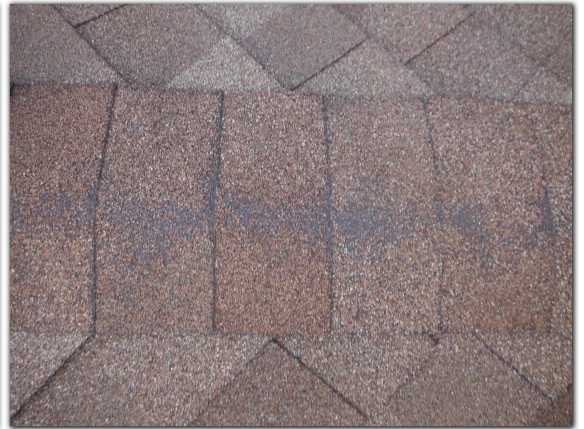
- Damaged shingles were observed on multiple sides of the roof structure.

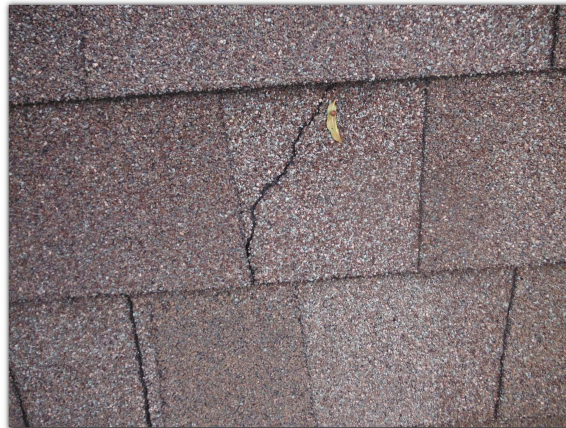
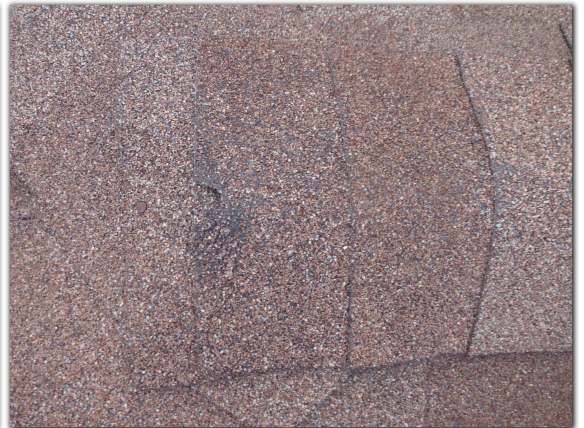
- Damaged drip edge shingles were observed on the east and west sides of the roof structure.

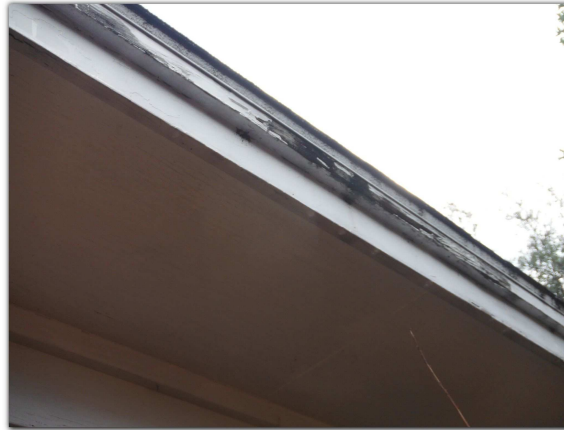
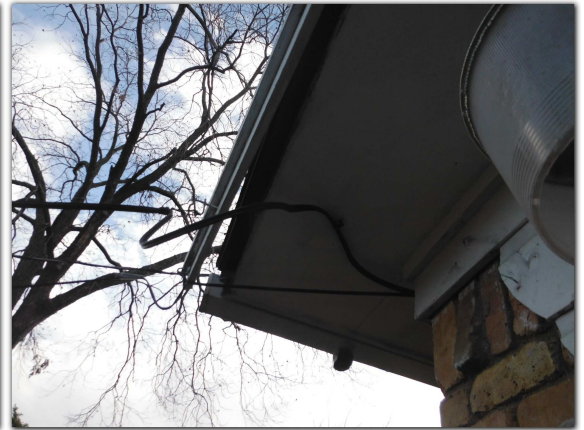
- The soffit material has some water intrusion observed on the east and west sides of the roof structure.

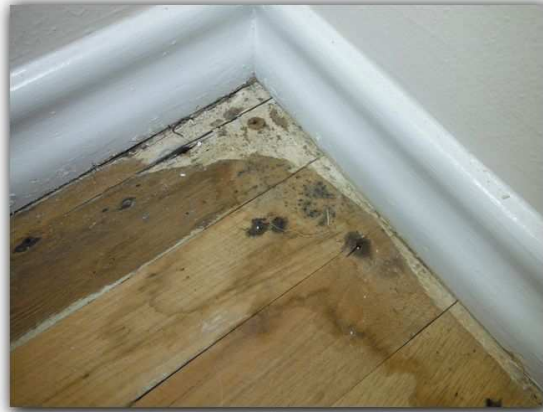
- The sub-floor material has some deterioration and/or damage under the furnace. This is a conducive condition for wood destroying insects and should be further evaluated and corrected as necessary.

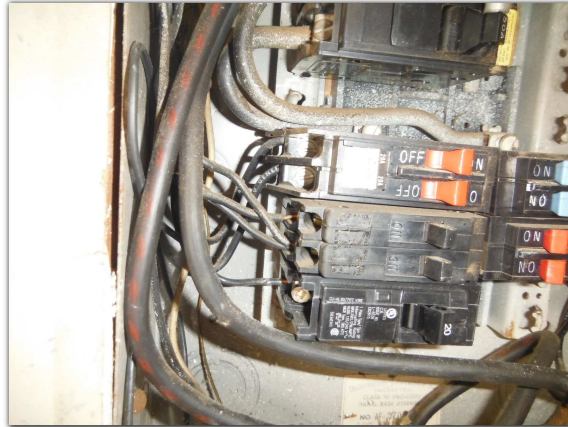
- One or more of the breakers in the electrical cabinet were observed to be double lugged (i.e. two wires under one screw). The breakers in place are not listed or labeled for this type of installation and should be corrected as necessary.

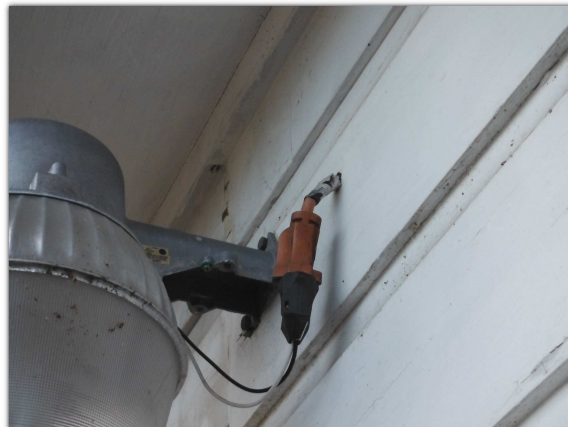
- Electrical flex extension cords should not be used for permanent wiring or pass through walls or ceilings. The improper use of extension cord was observed in or around the garage area.

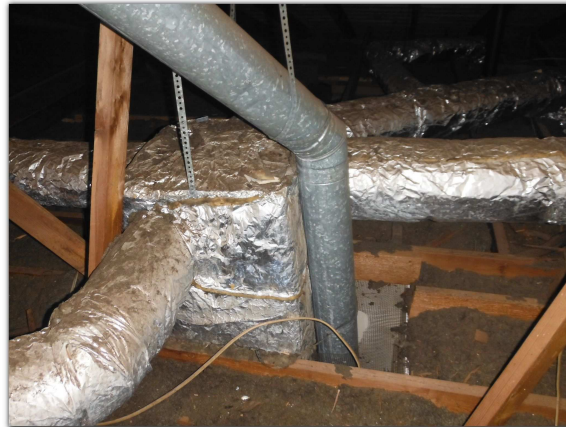
- The heating unit flue (vent pipe) has inadequate clearance from combustable materials. Double walled vent pipes should have at least 1-inch of clearance and single walled vent pipes should have at least 6-inches of clearance from combustable material.

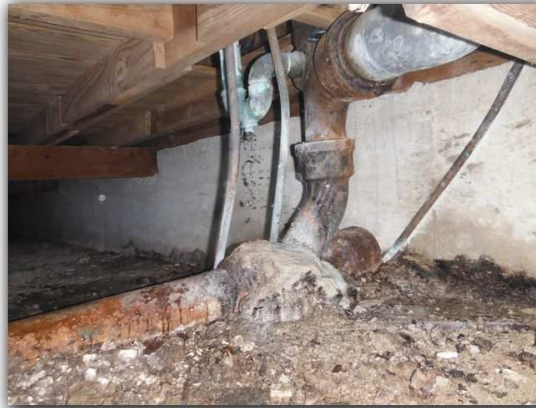
- Cracked, deteriorated and/or missing bathtub enclosure grout and/or caulking should be repaired or replaced as necessary.
- The bathtub drain is leaking water into crawl space area. The cause and remedy should be further evaluated and corrected as necessary.

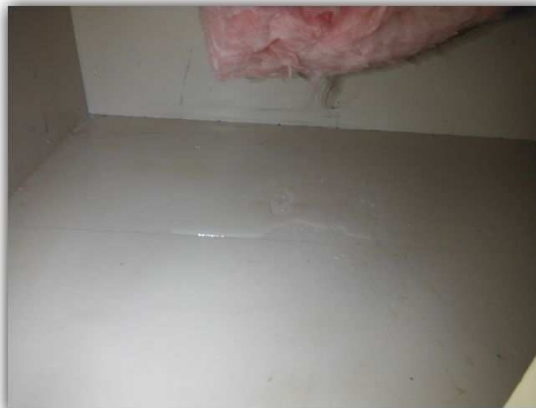
- The drain leaks water into the cabinet when drained under pressure with a large volume of water.

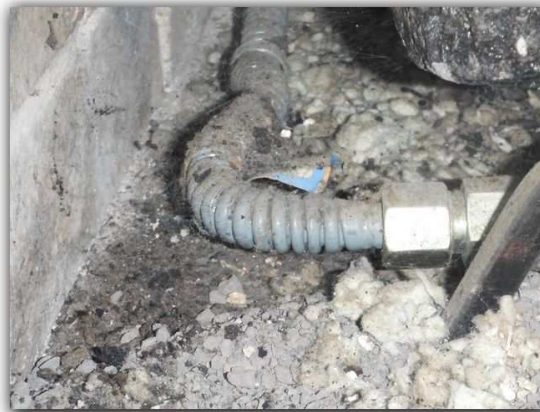
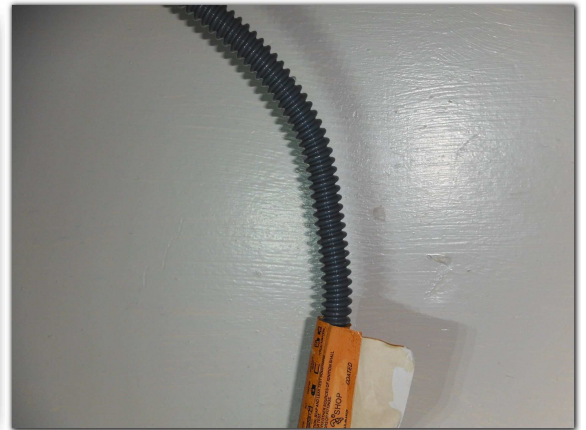
- The gas connections at the fireplace, cook top and built-in oven are made of a brass material that is no longer accepted for use with gas. It is recommended to replace these connectors before using the fireplace or appliances.

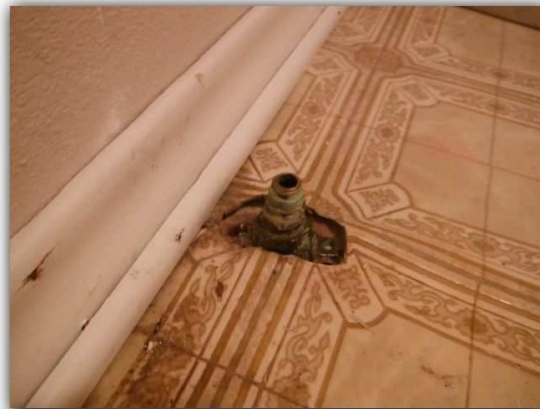
- All unused gas valve ends should be capped off for safety purposes at the laundry area.

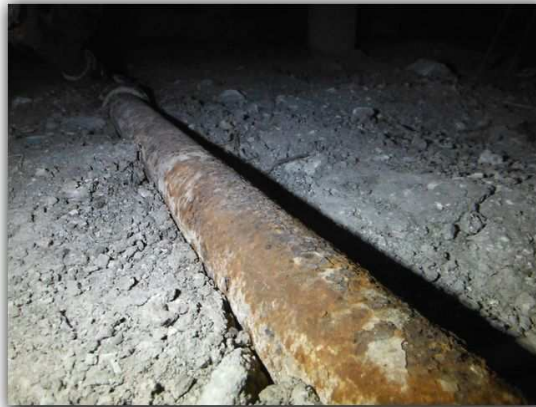
- **Notice:** When cast-iron piping is present in a home of this age, it is recommended to perform a hydrostatic test to determine the integrity of the drainage system. Cast iron piping that is more than 25 years old is reaching the end of its serviceable life and can cause damage to the foundation if allowed to leak over a long period of time.
- The master bathroom sink drain leaks water into the cabinet when drained under pressure with a large volume of water.
- The bath between rooms bathtub drain is leaking water into crawl space area. The cause and remedy should be further evaluated and corrected as necessary.
- The plumbing lines in the crawl space were observed to be lying on the ground. These lines should be raised and properly secured to a floor joist or beam.
