## GREEN SCENE HOME INSPECTIONS

MARCUS BUTLER INSPECTOR TREC #20819

## PROPERTY INSPECTION REPORT

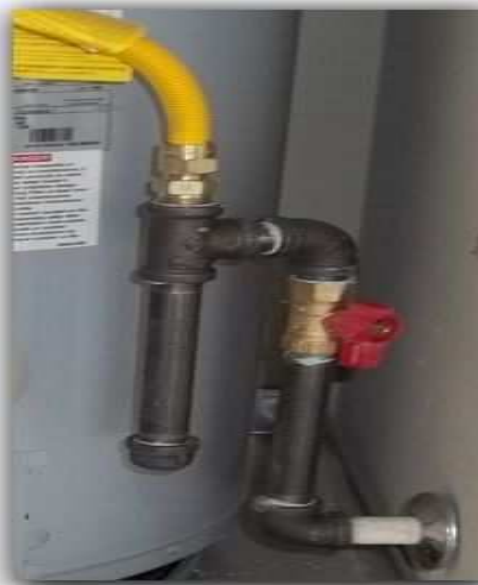
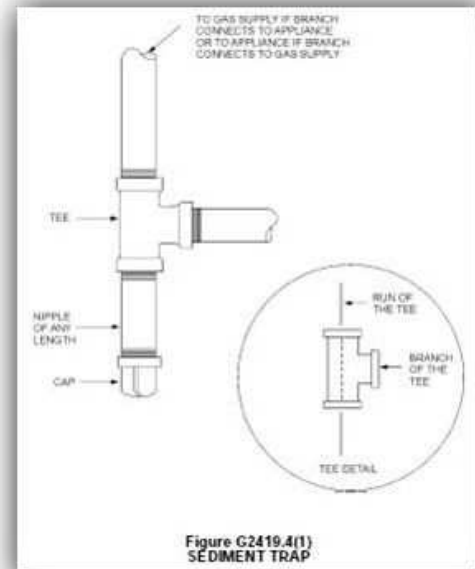
- **Note:** The pilot light was switched off at the water heater. The inspector turned the pilot on for testing and then turned it back off at the end of the inspection.
- **Note:** When the water heater was operated, water could be heard dripping inside the tank. This condition should be further evaluated and corrected as necessary.
- Some corrosion was observed on the water supply shutoff valve.
- The fittings at the top of the water heater are made of dissimilar metals (galvanized steel connected to copper and/or brass). It is recommended to replace the galvanized steel fittings with brass or copper fittings or install a dielectric union between the two dissimilar metals to prevent electrolysis from occurring.
- The water heater gas supply line is not equipped with a sediment trap just before the gas appliance connector. This condition does not meet current installation requirements.

- Sections of the water heater flue are in poor condition and further evaluation is recommended for reasons of safety.
